REPORT TO THE COASTWATCHERS ASSOCIATION ON DARGUES GOLD MINE AUGUST 2021

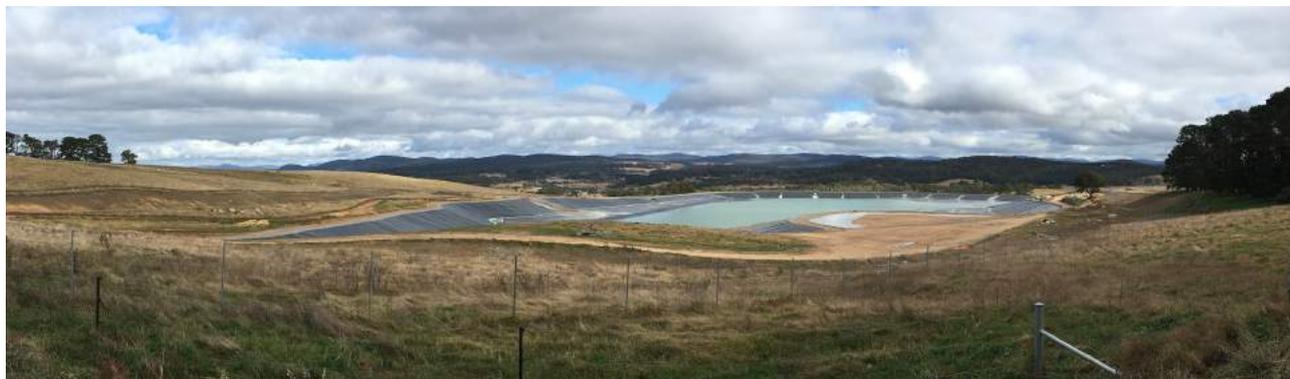
Owing to a wet period in the first half of 2021, the water level in the tailings dam reached its highest level in June and was seen by CCC members at the June mine inspection. The water level was well below the capacity of the dam - see *Figure 1*. Work is underway to raise the level of the dam further, which will increase the level of safety as regards containment of contaminated water, as well as providing extra space for tailings storage.

Figure 1. Tailings dam with tailings being discharged from a line of spigots on the far side on the inside of the dam wall; note narrow 'beaches' of exposed tailings; black material is the impervious liner; note bund (earth embankment) which diverts clean overland flow away from the dam; work is underway on the left hand side to raise the height of the containment.

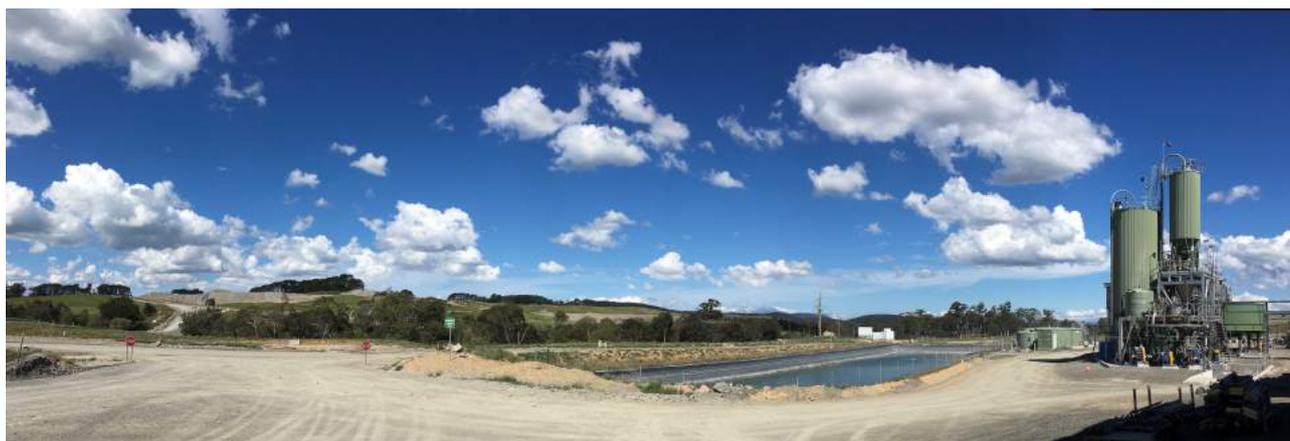
The mine site has been engineered to direct any contaminated waters into special catchment ponds to minimise the risk of polluting any watercourses that flow offsite and downstream into the Moruya River catchment. For example, runoff from the processing plant area drains into a pond which is recirculated into the processing circuit - see *Figure 2*. An adjacent pond collects sludge from the processing plant; recently this pond overtopped which resulted in overflow into the underground mine as designed, avoiding any release to or impact on the surface water drainage system.

Figure 2. Panorama from processing plant area showing processing plant ponds of contaminated water in centre; mine access road and waste rock dump on skyline at left; the tailings dam wall behind the ponds.
